TECHNICAL REPORT C-13

Systems Approach to Life-Cycle Design of Pavements

**METHODOLOGY AND EFFECTIVENESS
OF DRAINAGE SYSTEMS FOR AIRFIELD PAVEMENTS**

by
Harry R. Cedergren

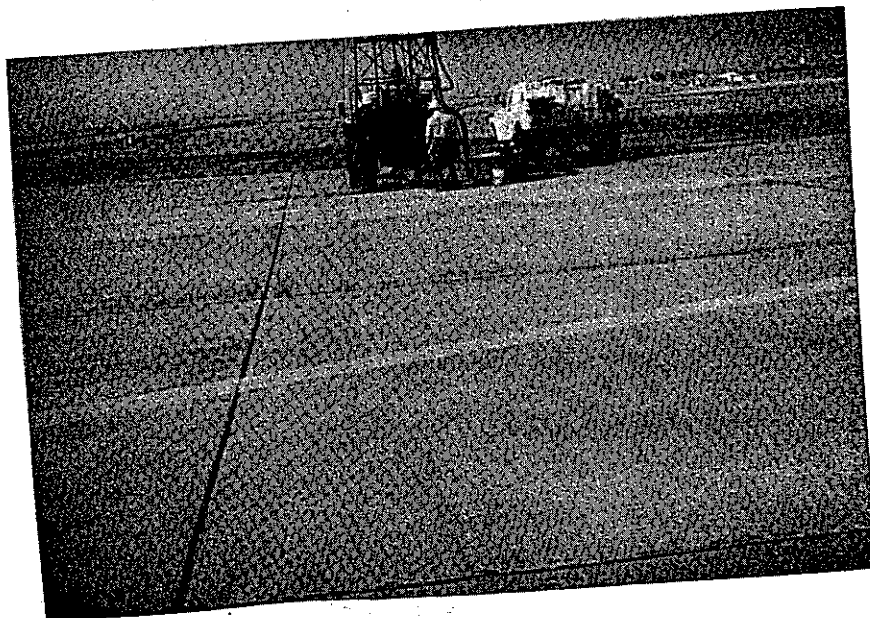
Figure C-2. Drill rig at Well 4; this area has poor surface drainage and very slow subsurface drainage; free water stays in structural section a long time after it stops raining.

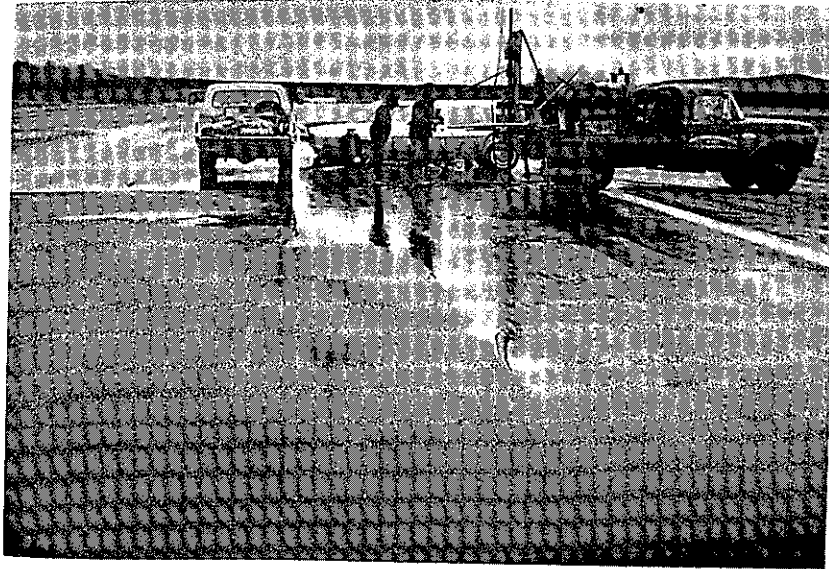
Figure D-2. Photo of drilling equipment at Well 1; near centerline of Taxiway G at Calibration Hardstand; stopped raining about 2 hours ago; some water entrapment on surface of pavement.

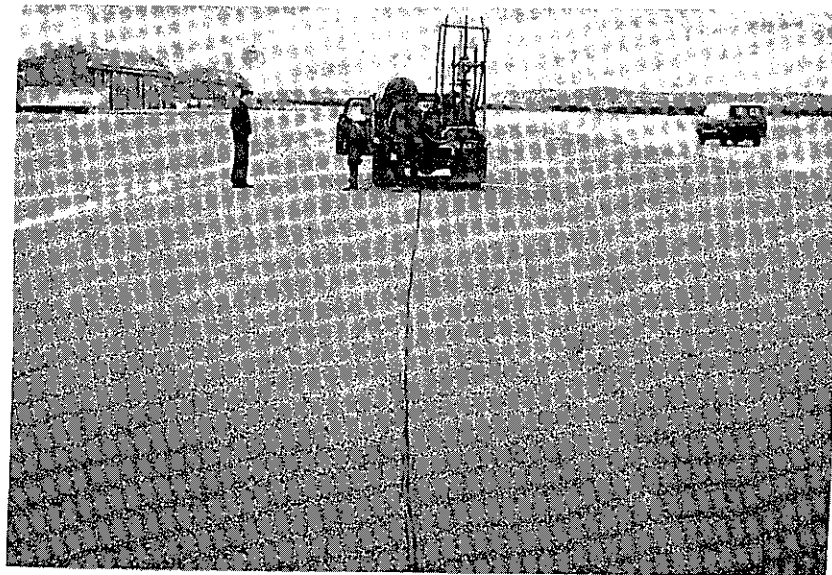
Figure D-3. Photo of drilling equipment at Well 4; Taxiway G at Dock 32; base course under 6-in. thick AC pavement is very open-graded trap rock.
